# Sharing of Fire Incidents in Waste Management Industry

# Case Study 1

# Case Study 2

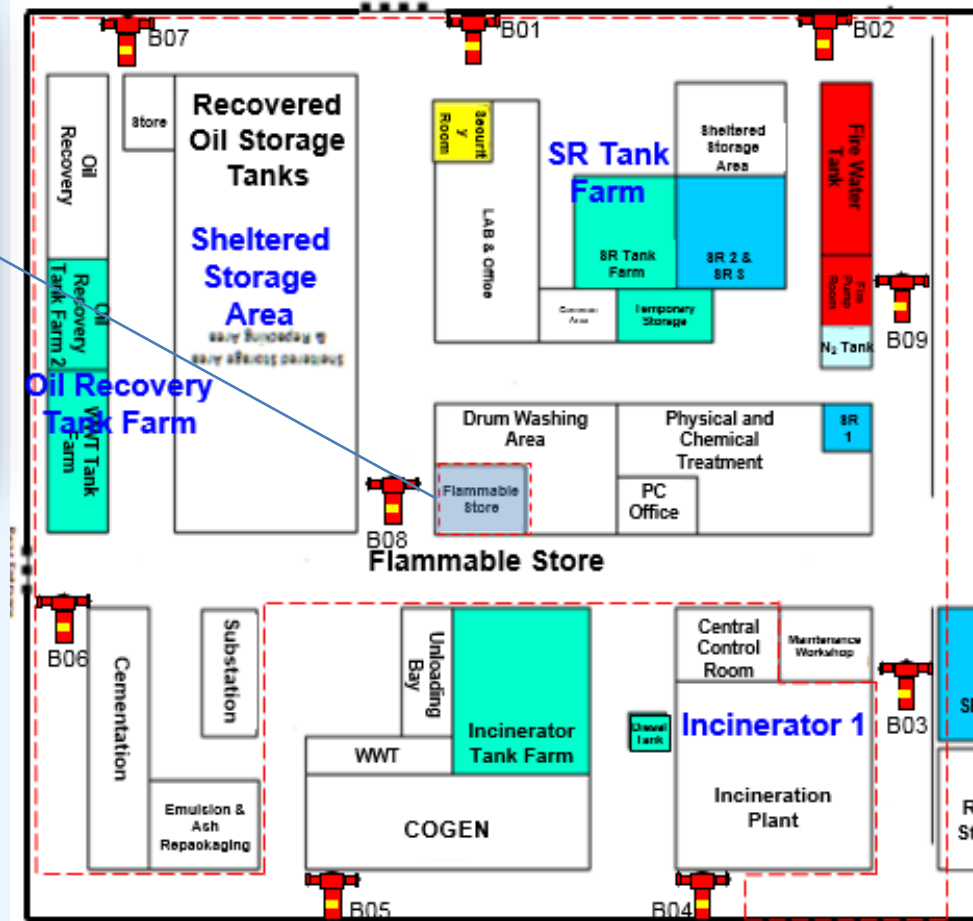
- Monitoring of hot spots & chemical gas leaks
- Detection of low levels of ammonia

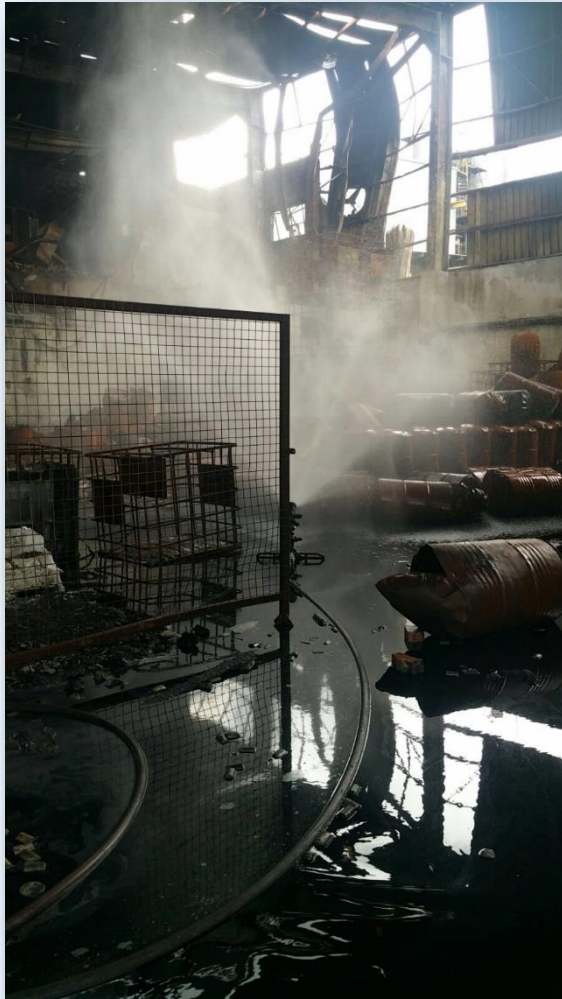
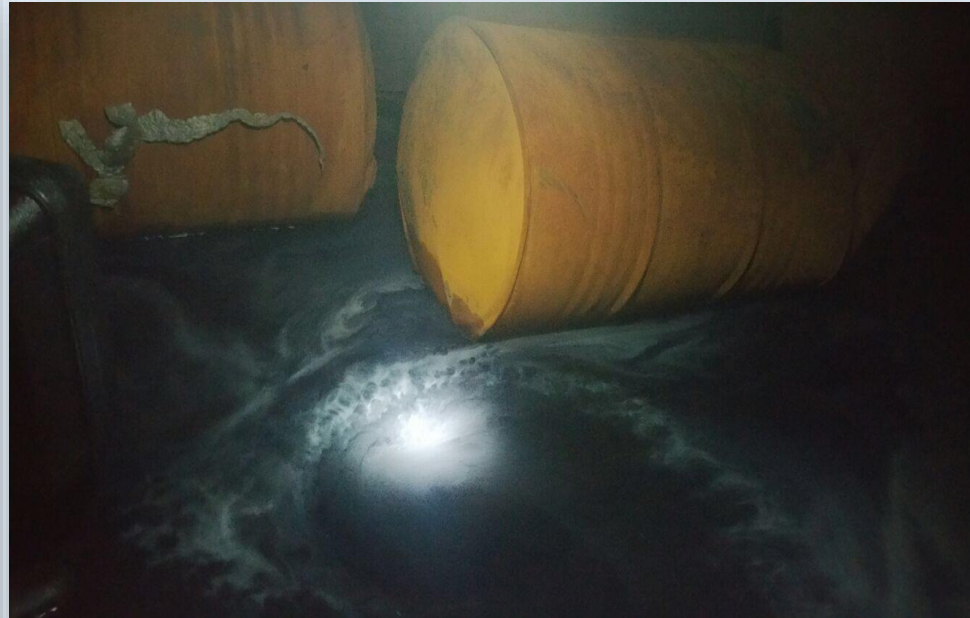
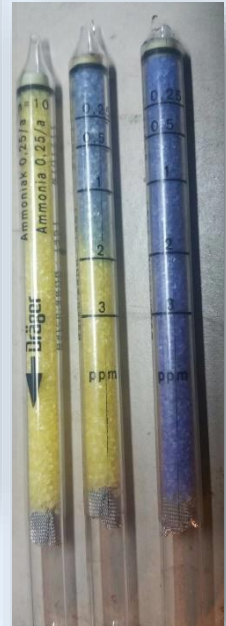
- Use of vapour dispersion jet
- Several small cracks (~1cm in diameter) mitigated by HIT

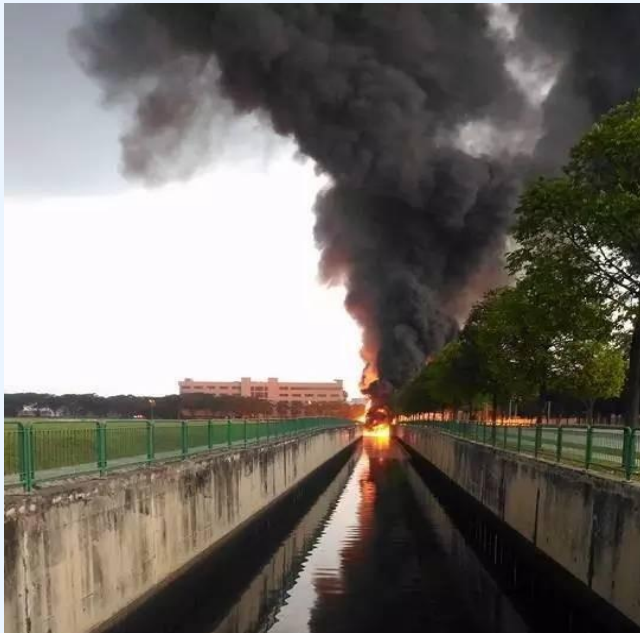
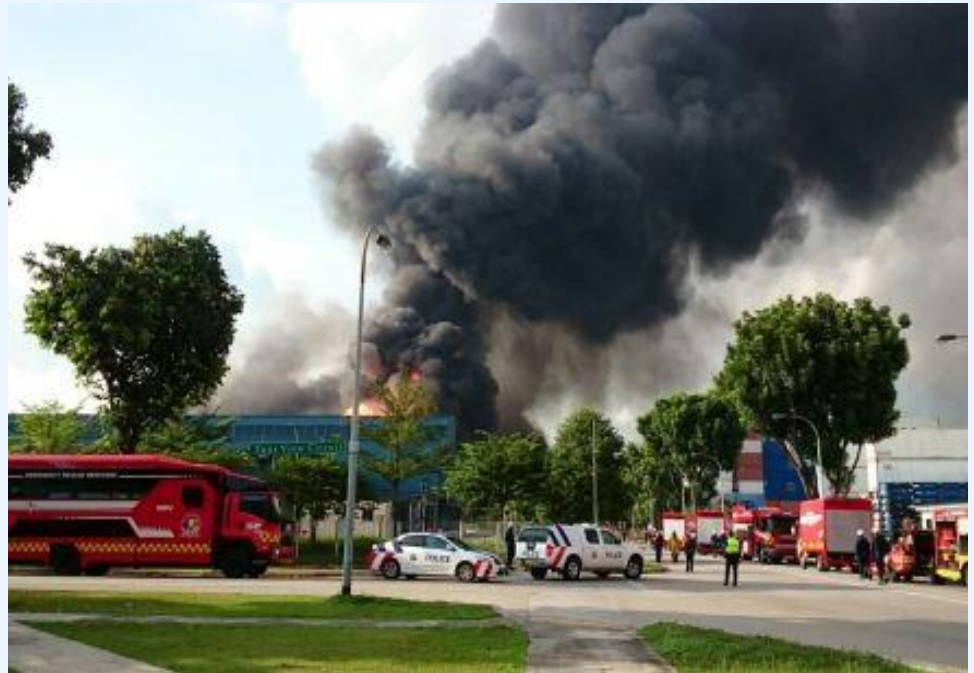
- Chemical spilled into drainage system resulting in rapid fire spread, extended to Tuas South Ave 7

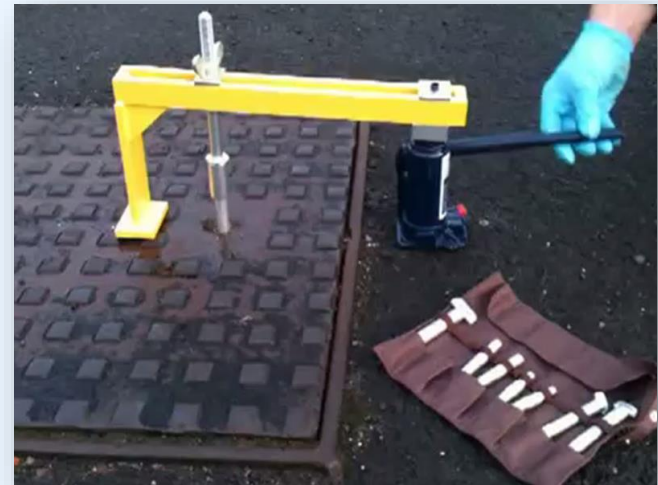
- Insufficient & inconsistent water supply
  - ✓ Hydrants all running on same supply line
  - ✓ Reduce number of jets. Focus on critical areas
  - ✓ Tapping on private hydrants of nearby buildings
- Multiple hydrant pit covers jammed along Tuas South Ave 3
  - ✓ Despite PUB's assistance

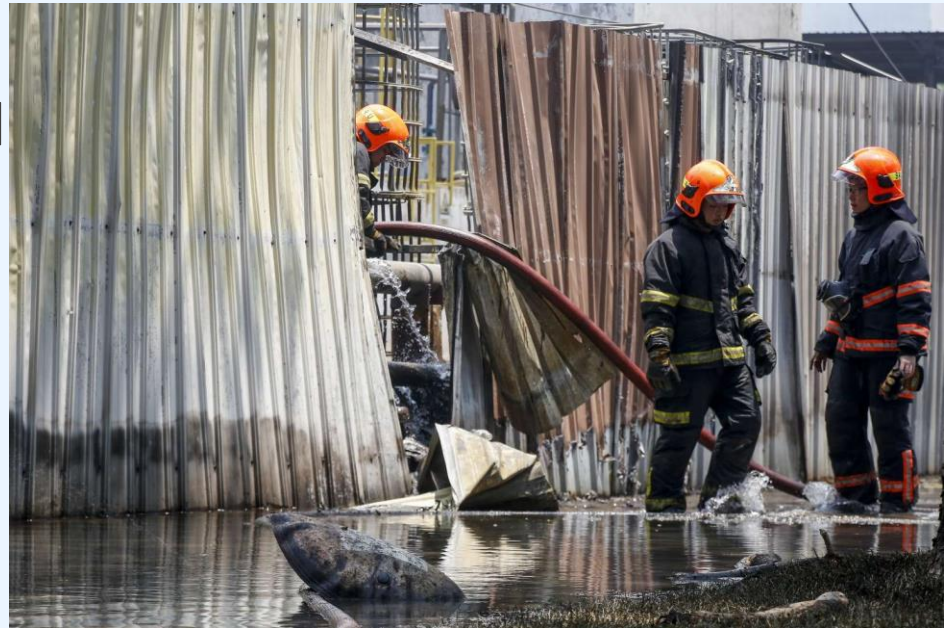
- Flooded with chemical waste sludge which heavily stained PPE
  - ✓ Lack of a proper decon point for quick wash down
  - ✓ Water jets unable to completely remove the chemical contamination
  - ✓ Contamination hazard

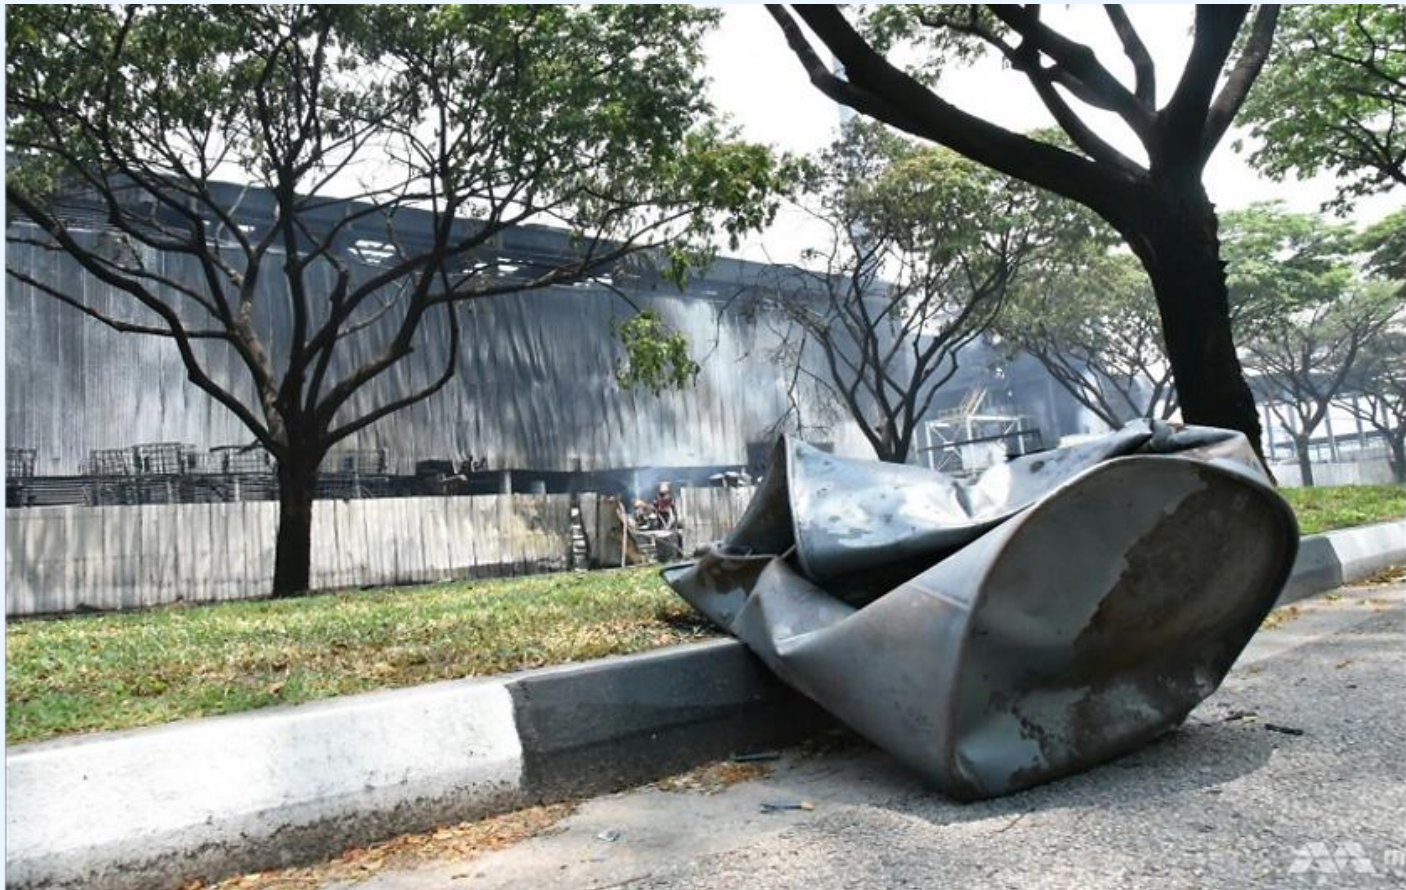
*200l steel drum along on Tuas South Street 3*

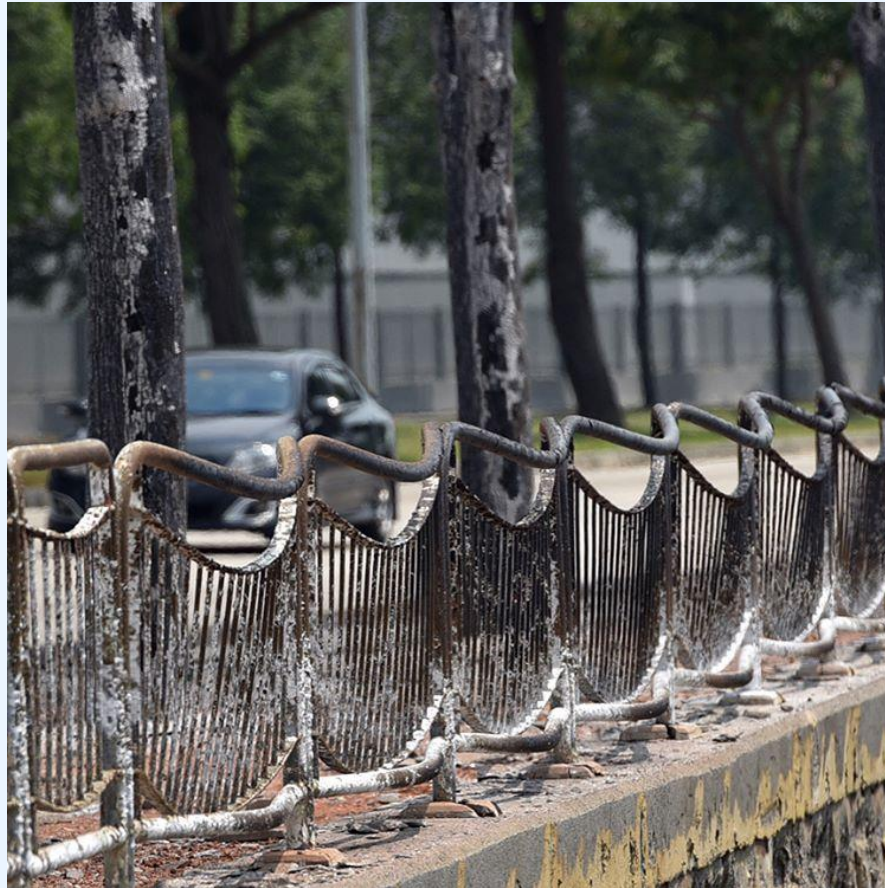
*Metal railings damaged by the fire spread along the drain of Tuas South Ave 7*

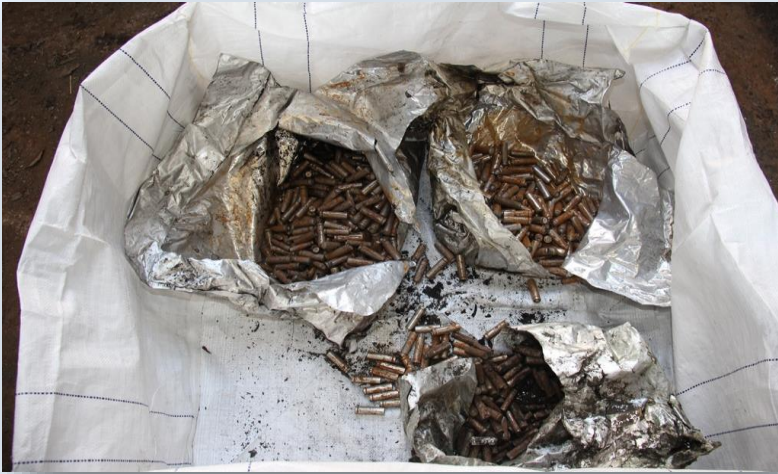
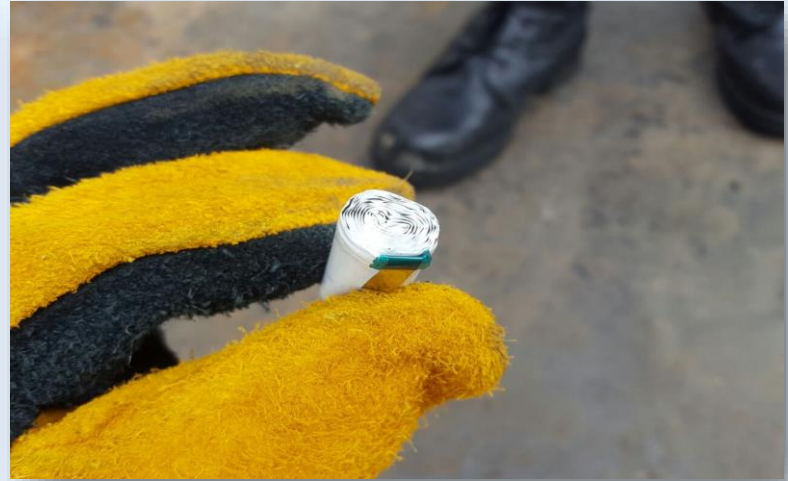
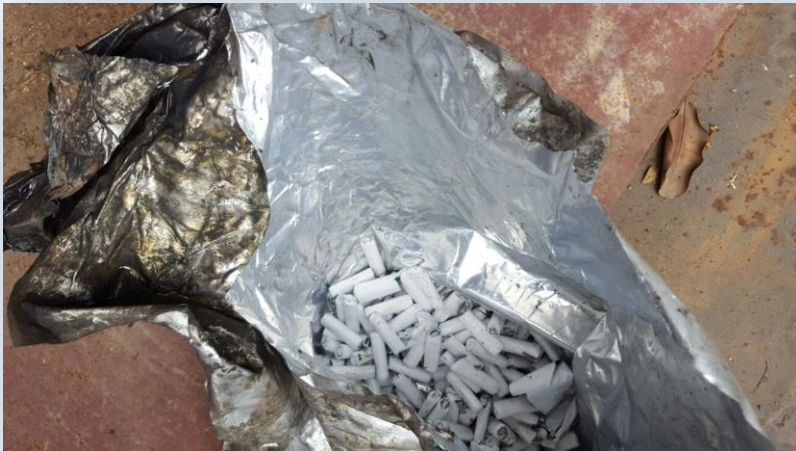
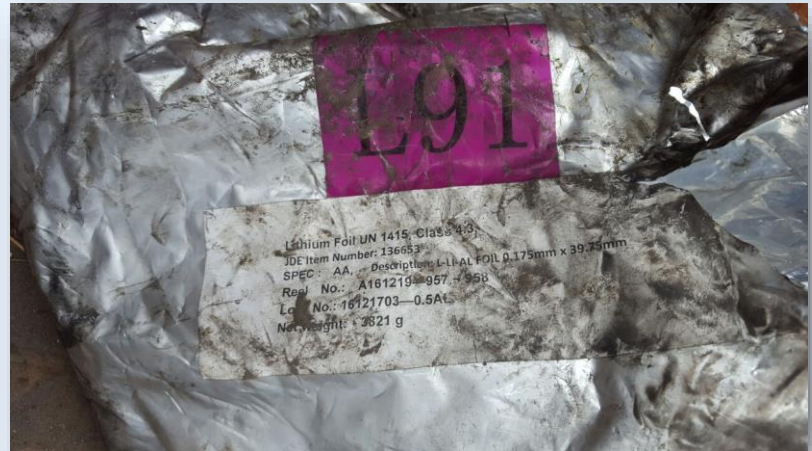
# Batteries

- The presence of the bags of batteries were not made known earlier
  - ✓ Explosive chemical reaction of the lithium batteries and water
- Although the surface fire was extinguished, there were deep seated ambers within the 3 x 3m-high stacks of general waste
  - ✓ Large amount of debris and many were oversized items (large reels of cables, large tyres etc)
  - ✓ Use of the company's excavator
