# Sharing of Fire Incidents in Waste Management Industry

# Case Study 1

# Case Study 2

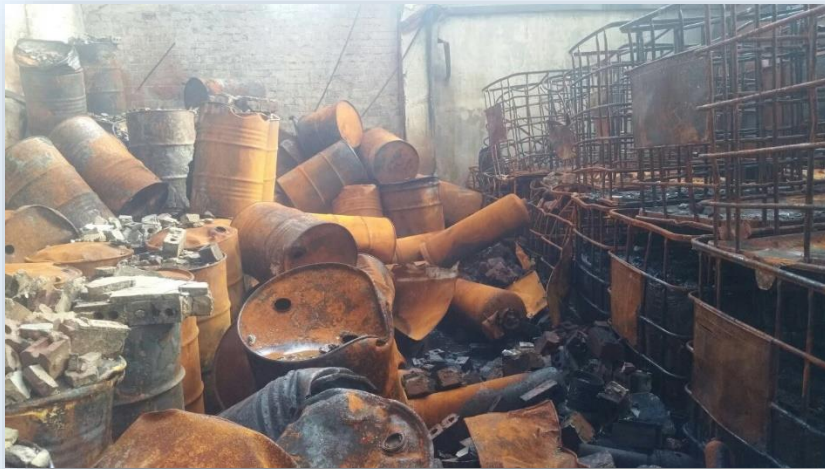
- Monitoring of hot spots & chemical gas leaks
- Detection of low levels of ammonia

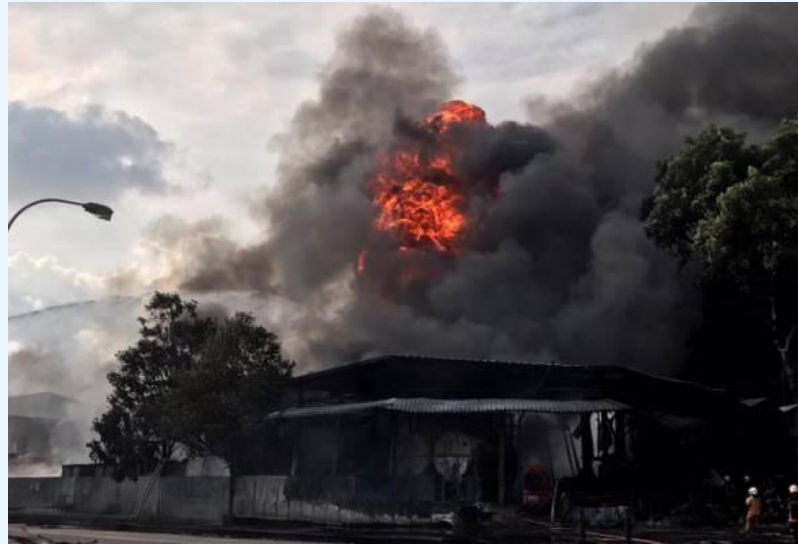
- Pungent smell from burning chemicals
  - ✓ BA sets for personnel entering the site
  - ✓ N95 masks were used but found to be ineffective
  - ✓ Health concerns of responders who attended for the call
